SHEET 1 OF 3	MONUMENT RECORD CORNER ID: CICr_Q25	Section Corner Section 34 & 35- T07N-R01W Clear Creek Township Monroe County, Indiana	MONROE COUNTY GOVERNMENT	OFFICE OF THE MONROE COUNTY SURVEYOR Trohn Enright-Randolph Monroe County Surveyor Rachel Savich Oser Professional Surveyor 119 West 7th Street, Bloomington, IN 47404 (812) 349-2570
-----------------------	---	---	---	---

MONUMENT RECORD
CORNER ID:
C1Cr_Q25

Section Corner
Section 34 & 35- T07N-R01W
Clear Creek Township
Monroe County, Indiana

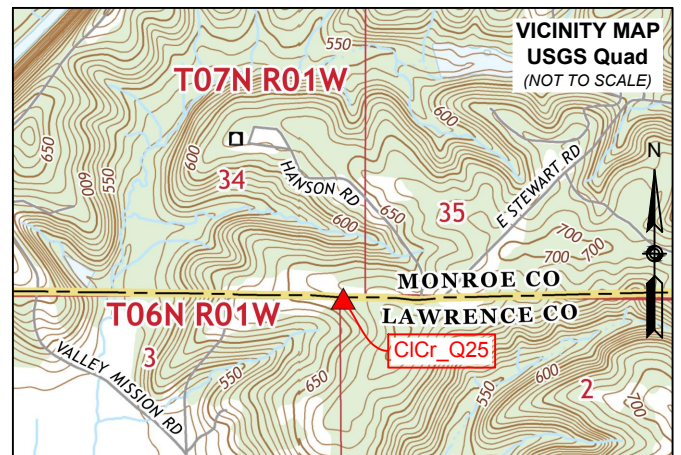
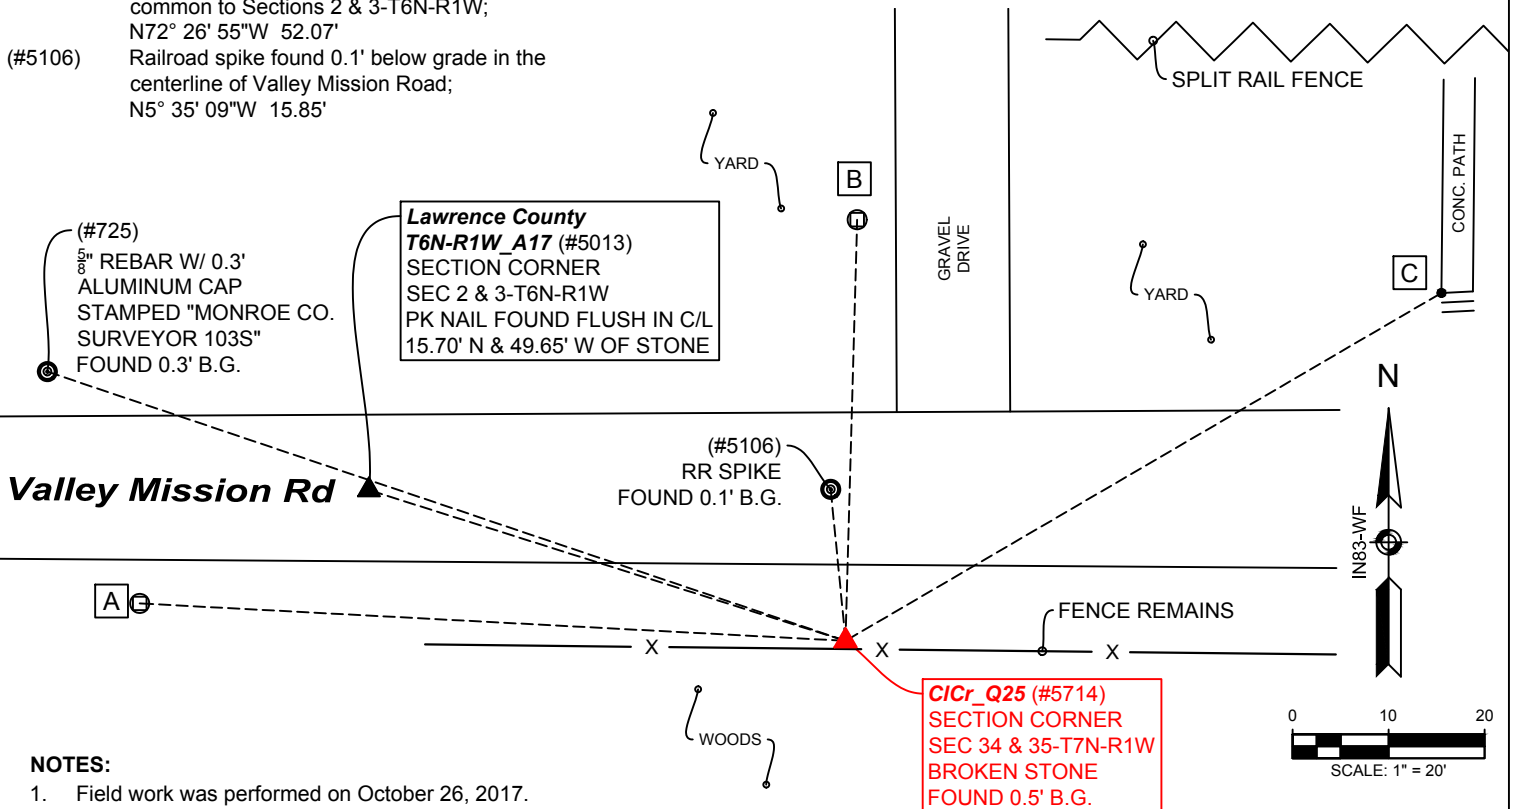
The stone was found 7.9' south of the south edge of asphalt of Valley Mission Road, in line with the remains of east/west fence.

▲ **Monument Description:** A 0.9' x 0.25' limestone with no markings was found broken off 0.5' below grade. We located the center of the base, planted a magnet on the south side, placed the broken top on the base, painted it orange, and reburied it.
State Plane Grid Coordinates: Northing: 1363973.5', Easting: 3118937.2'

A 5' steel t-post was set 3.2' above grade, 0.35' south of the stone. A Monroe County Surveyor Marker sign was attached 2.2' above grade facing north. A magnet was planted on the south side of the stone. The stone was painted orange and the broken top was set back on the base and reburied. Several rocks were placed around the broken and exposed top of the stone, but not enough to be described as a cairn.

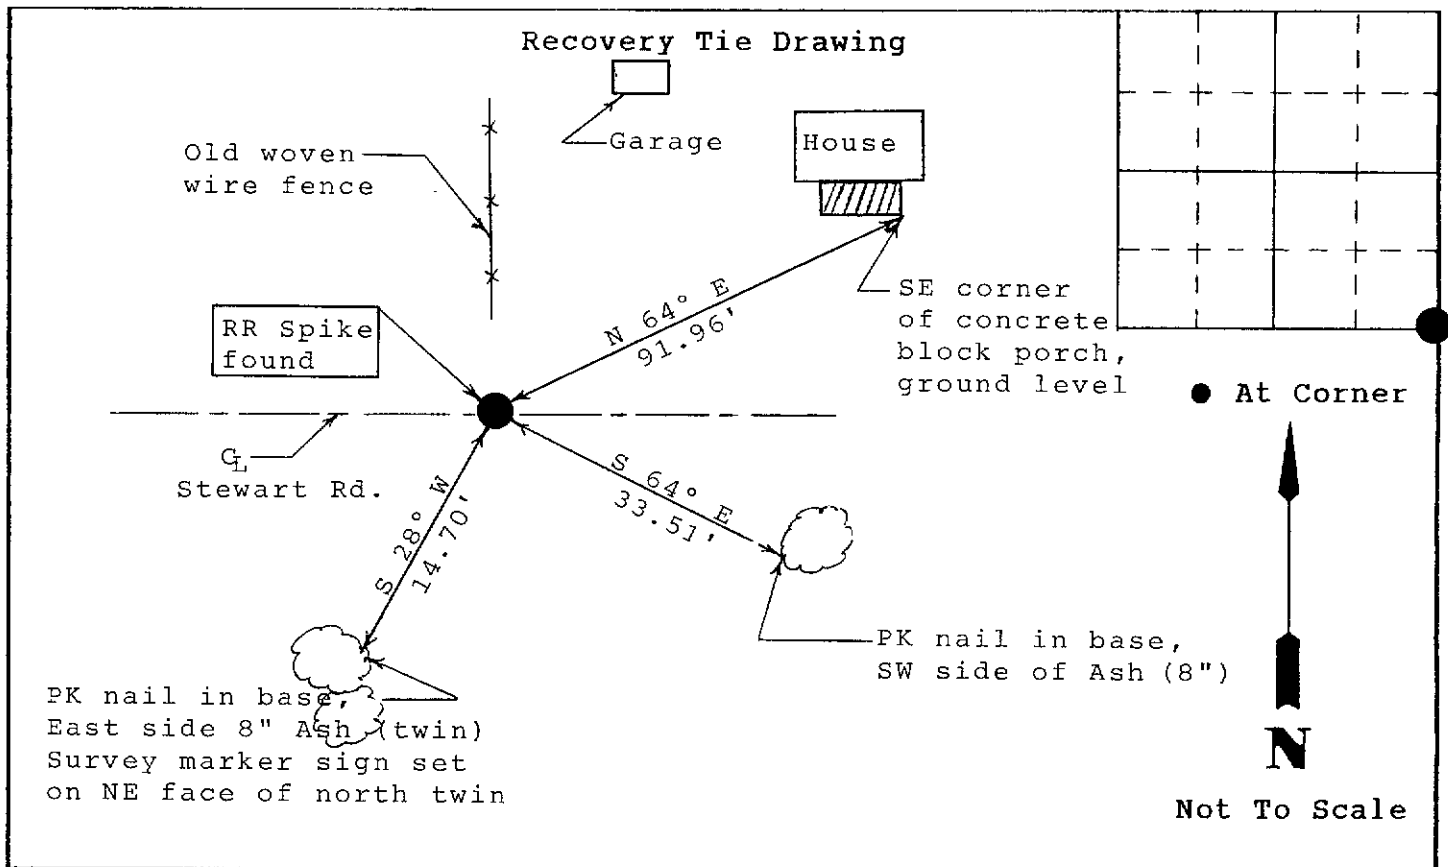
Monument Description & Remarks: Found Railroad Spike, 1/2" below surface
in centerline. Railroad Spike marks the SE corner of section.
